**Smoky Canyon Mine  
Non-Time-Critical Removal Action (NTCRA) – 2015 Activities  
Pole Canyon Overburden Disposal Area**

**Weekly Construction Report**

Prepared by: Formation Environmental (on behalf of the J.R. Simplot Company)

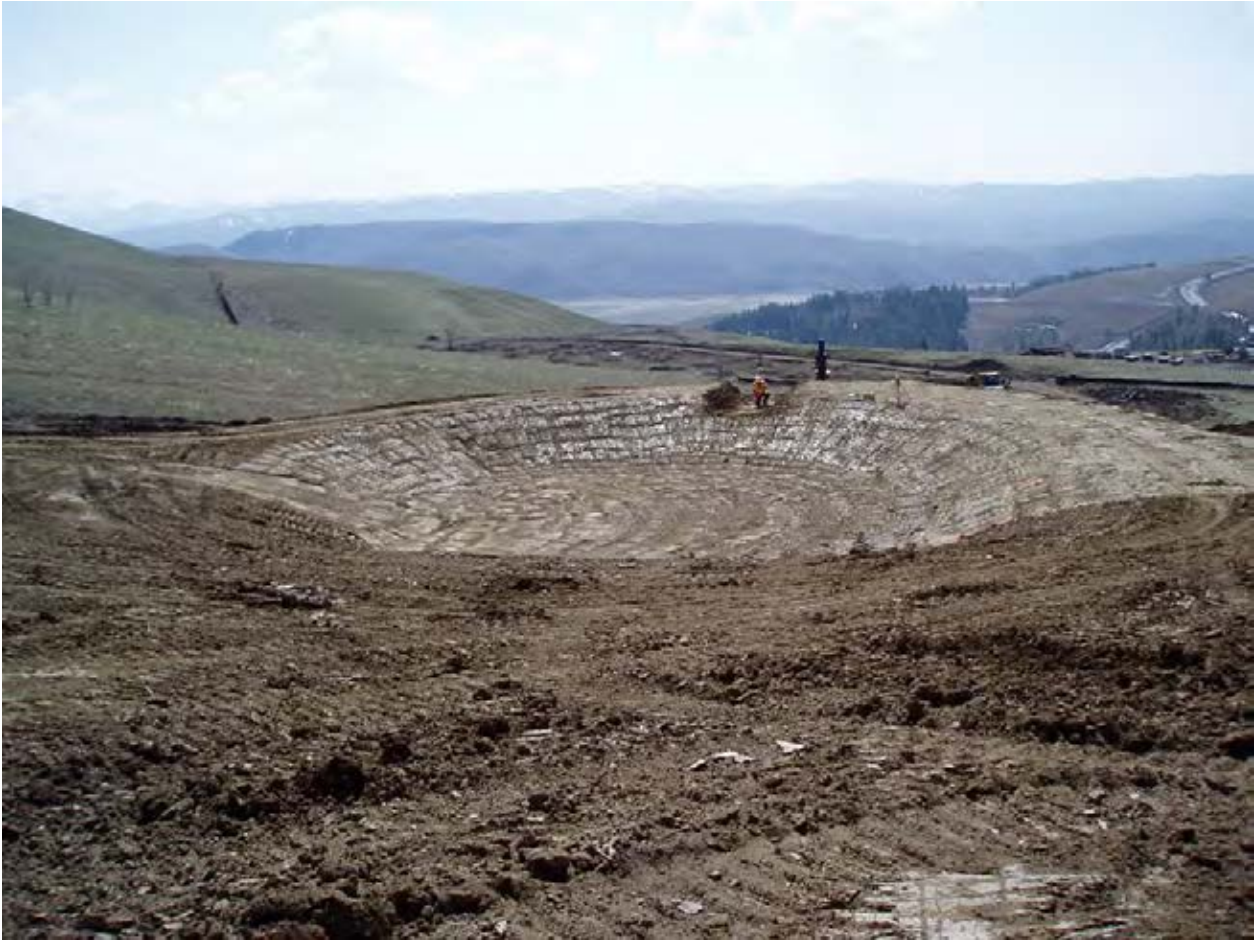
Photograph 3: Dinwoody Borrow Area South Sedimentation Basin and Embankment. Field engineer testing moisture and density of fill material in spillway excavation subgrade with nuclear densometer.

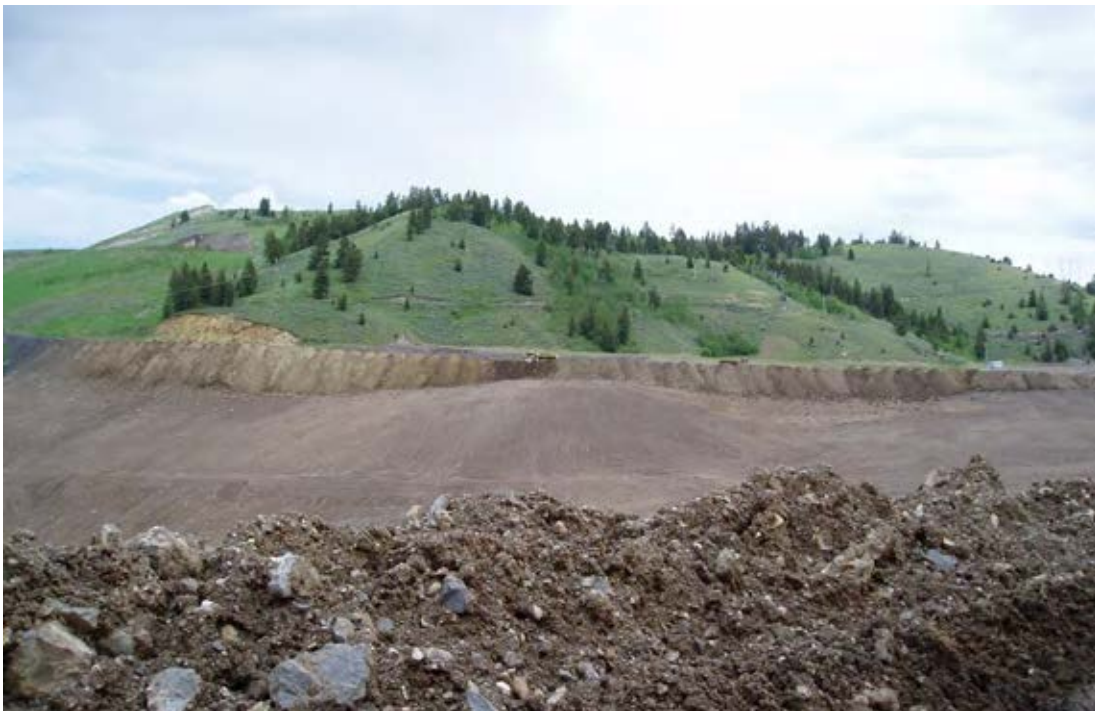
Photograph 3b: Looking northeast towards WS-R1 as Dinwoody material is being hauled to rind stockpile while dozer maintains safe conditions.

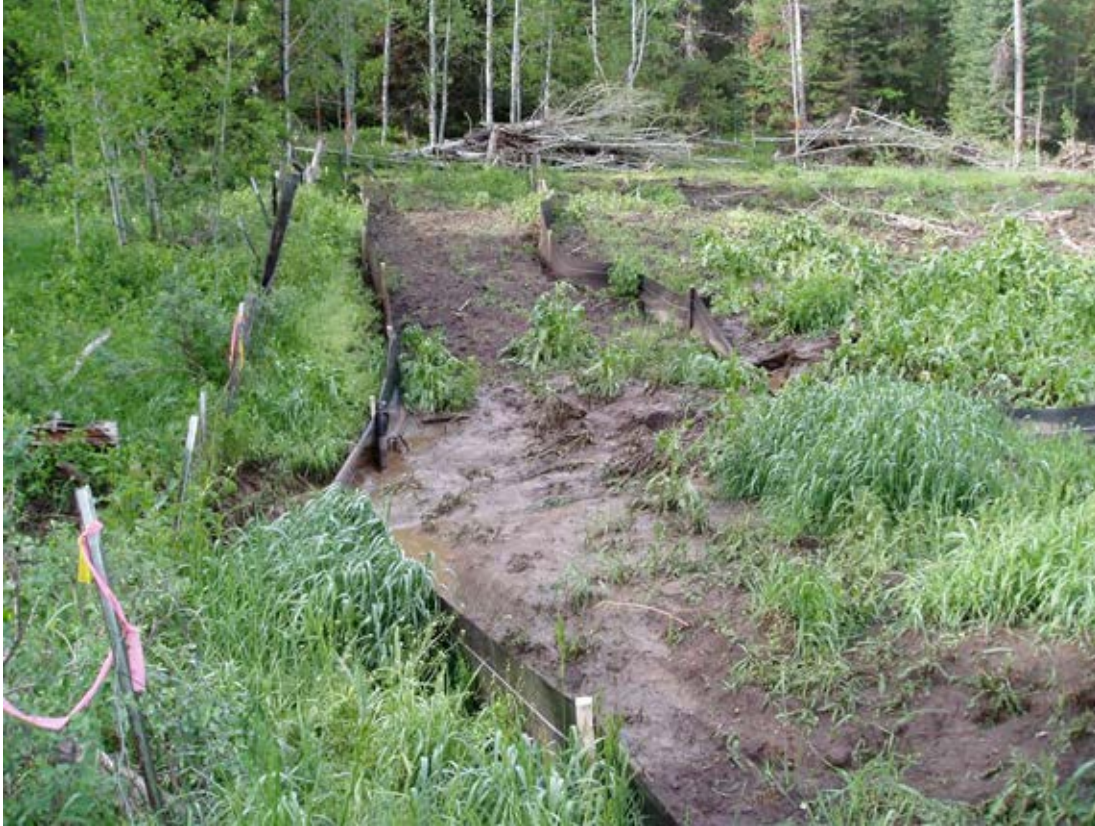
Photograph 4a: Looking south along silt fences downstream of temporary east side sedimentation pond, Wednesday morning 6-10-15. Sediment and silt fences were removed and new silt fences were installed.

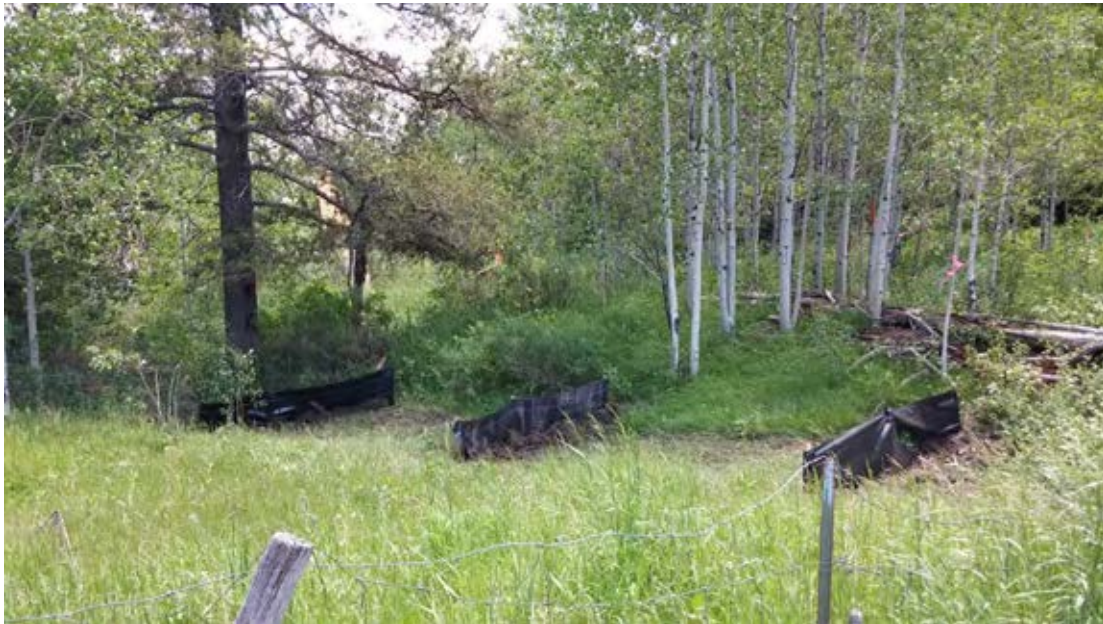
Photograph 4b: Looking south east immediately downstream of Photograph 4a above. In addition to the removal and replacement of the silt fences just upstream, a series of three silt fences were installed downstream at this location, Wednesday afternoon 6-10-15.

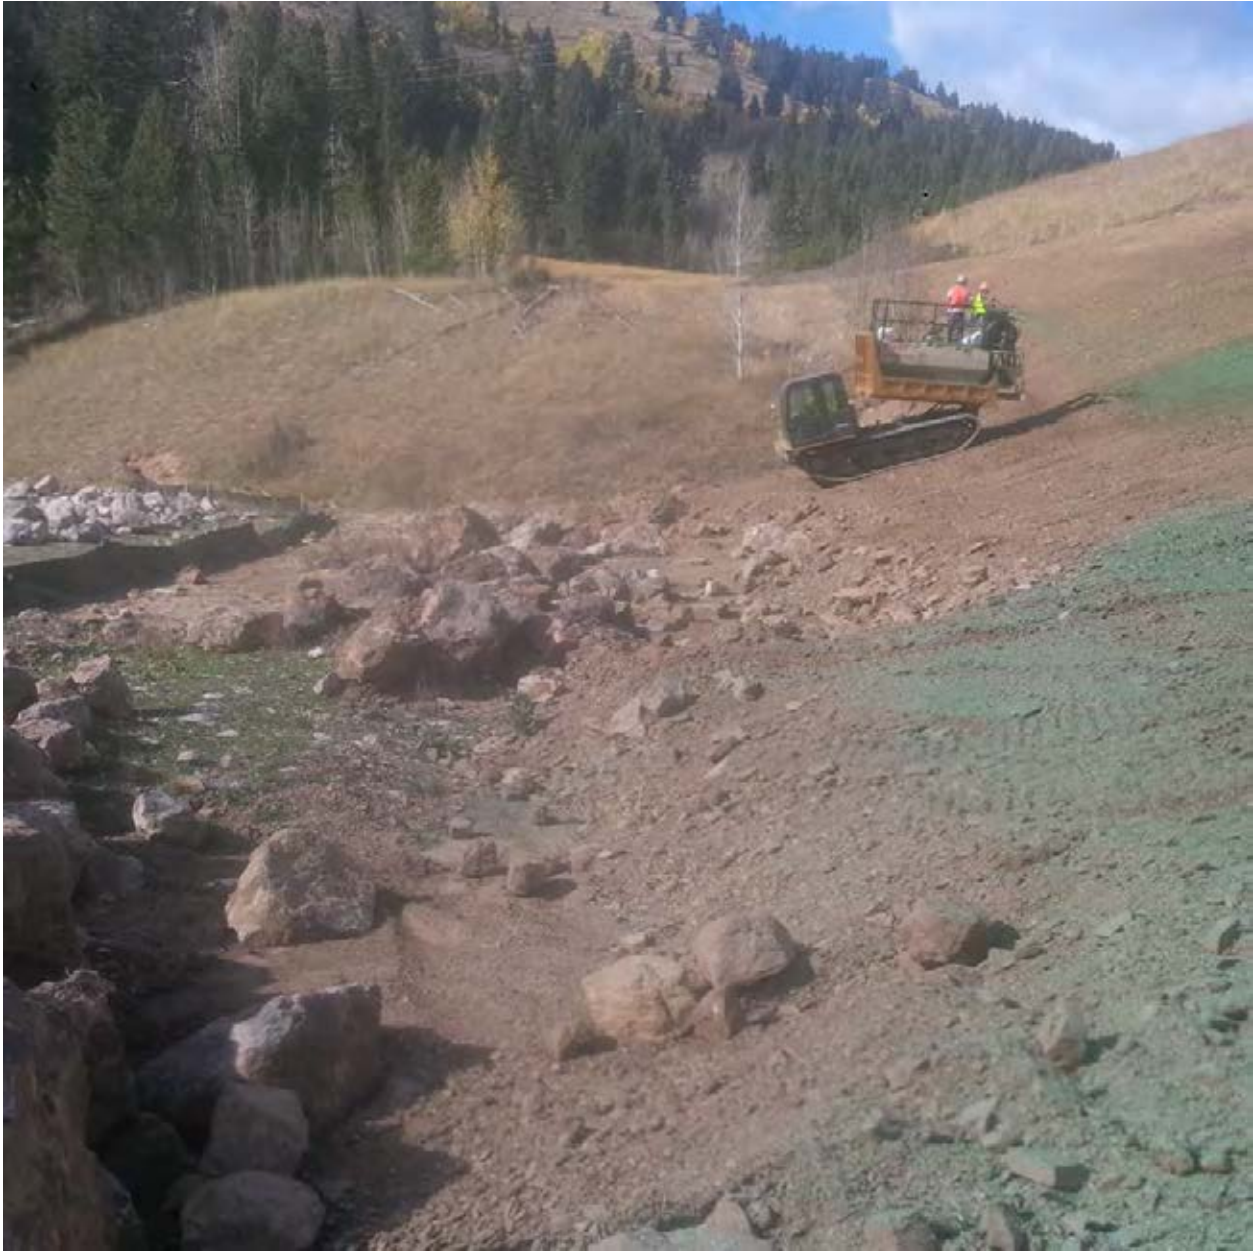
Photograph 4: Top east side of ODA requiring final grading to eliminate ponds; pad for Blast Compound and final contractor staging area to left (not shown).

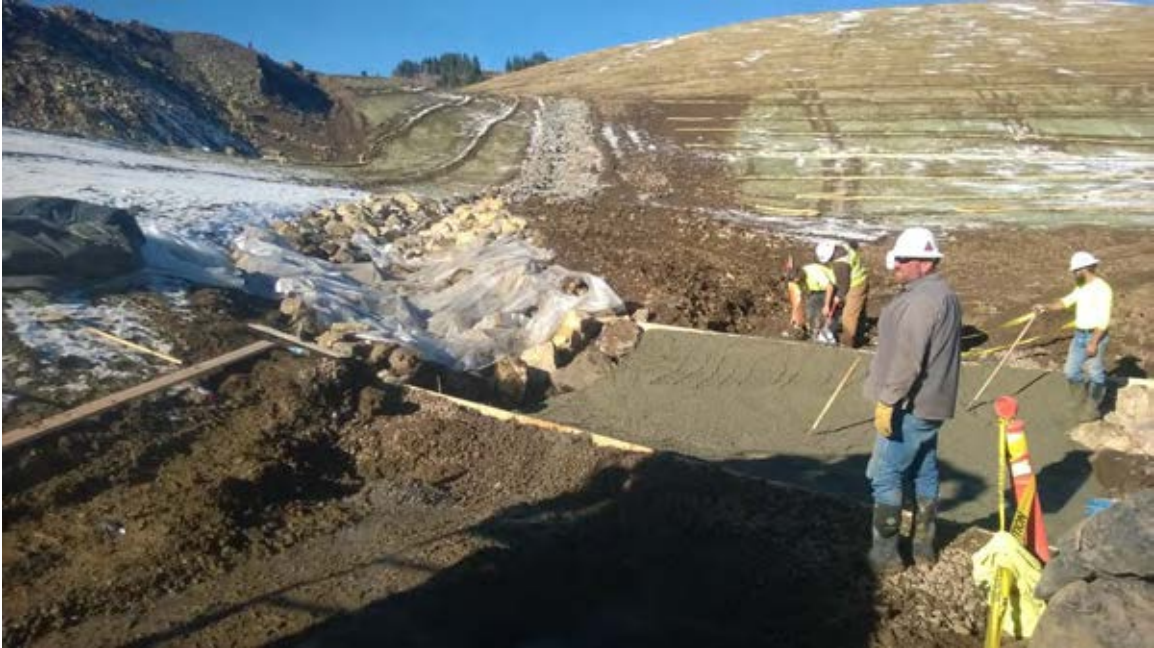
Photograph 1b: Looking north along Upper East Side Chute and Concrete Swale at Access Road Crossing as ready-mix concrete is being placed for drainage swale. Swale will provide access to lower east side during dry and low flow conditions.

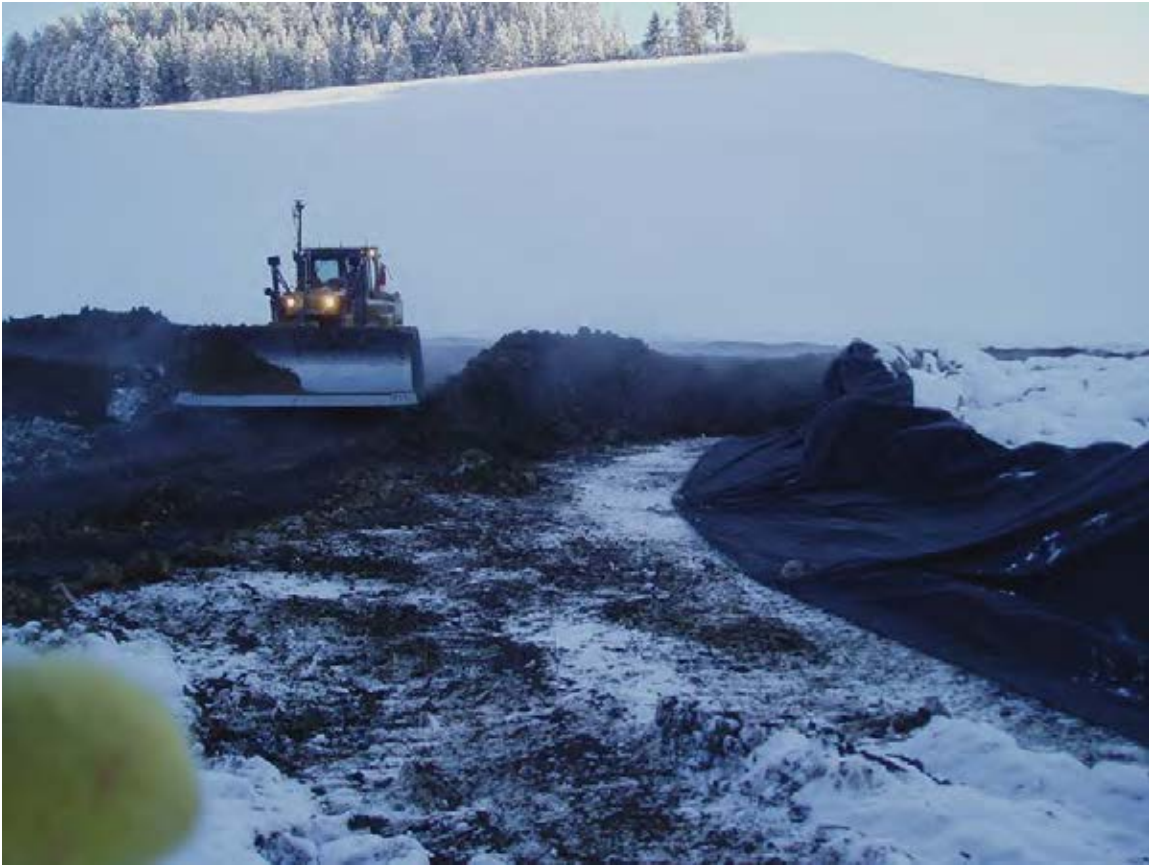
Photograph 9: Looking south at the West-side Toe of the ODA immediately above rip rap for infiltration basin as dozer grades Dinwoody to promote drainage around to the sides of the infiltration basin. Geofabric placed against the rip rap to prevent washing of the cover into the rip rap face of the infiltration basin.

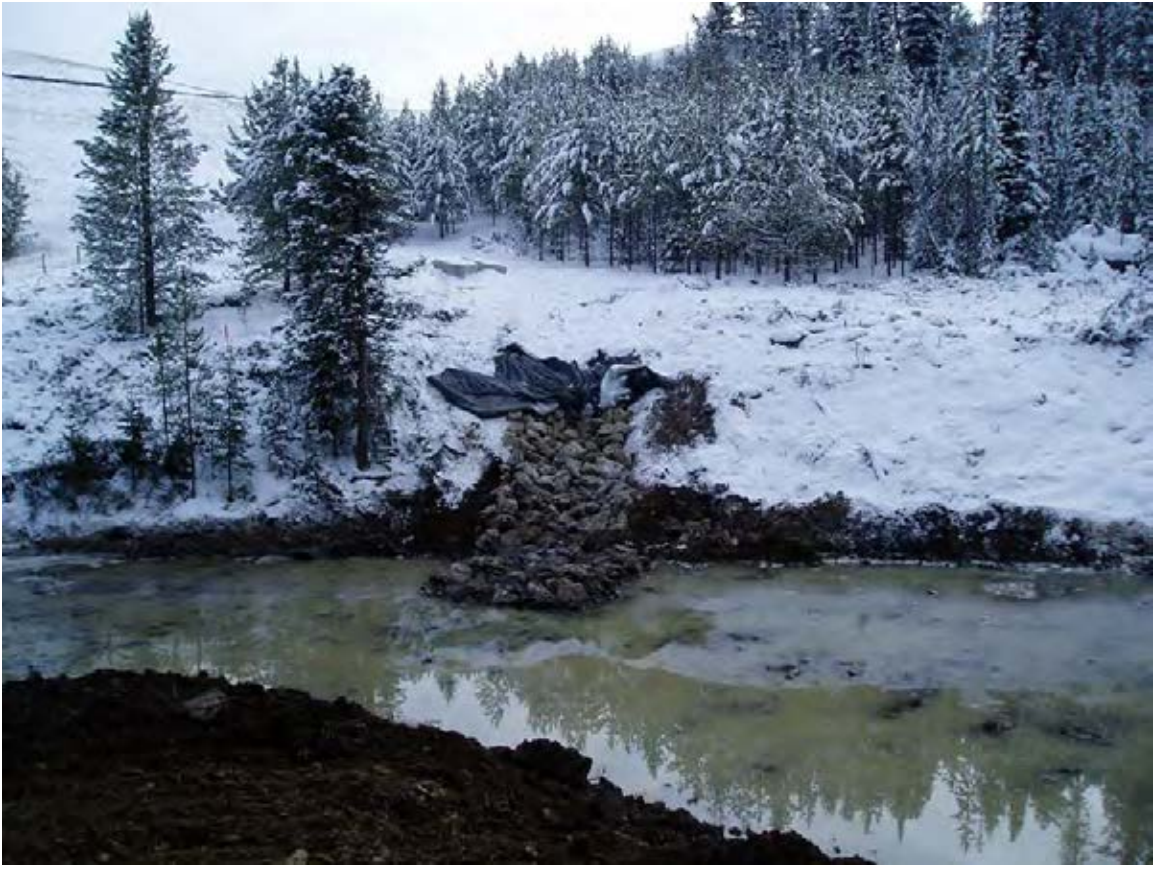
Photograph 10: Looking south towards recently placed geofabric and rip rap for the West Side Run-off Control Ditch outfall into the West-side West Sedimentation Basin. Black objects above rip rap are insulating blankets to be used once rip rap is grouted.
